# **HOT CORROSION OF NICALON FIBER REINFORCED GLASS - CERAMIC MATRIX COMPOSITES: MICROSTRUCTURAL EFFECTS**

R. W. Kowalk, S-W. Wang and R. R. Sands  
Mission Avionics Technology Department (Code 6063)  
NAVAL AIR WARFARE CENTER  
Aircraft Division Warminster  
P.O. Box 5152  
Warminster, PA 18974-0591

**NOVEMBER 1992**

FINAL REPORT

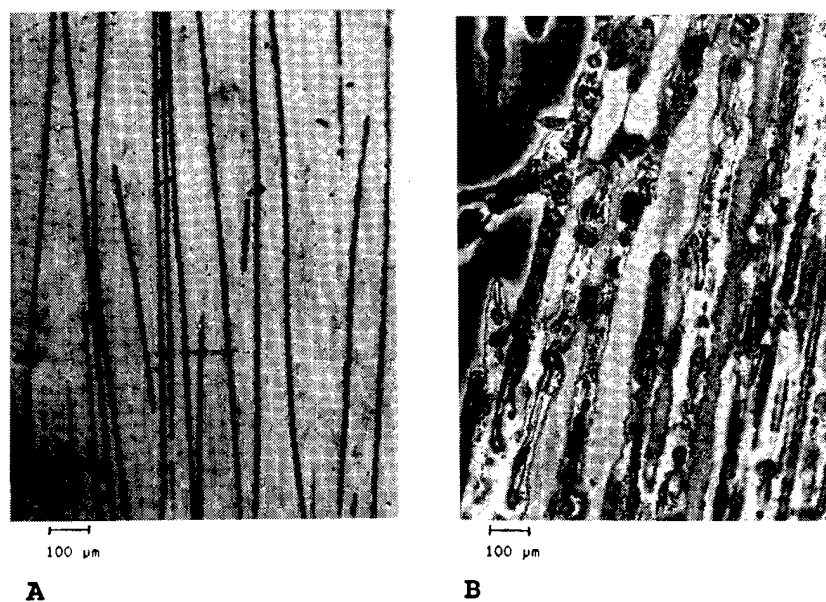
A micrograph of the as-received SiC/CAS composite is presented in Figure 1a. It can be seen that the silicon carbide fibers are exposed on the specimen's surface. After a 1-hour heat treatment at 900°C, a reaction took place at the exposed fibers, as seen in Figure 1b. Analysis of the X-ray profiles presented in Figure 2, indicates the presence of two new phases: calcium silicate ( $\text{CaSiO}_3$ ) and sodium aluminum silicate ( $\text{NaAlSiO}_4$ ). This was further verified by X-ray image analyses of the surface and of the cross section as seen in Figures 3 and 4. The calcium rich phase is depleted of sodium and aluminum while the other phase is rich in Al and Na. Therefore, a possible reaction sequence is as follows:

Gas evolution, which may be  $\text{SO}_3$ ,  $\text{SO}_2$ ,  $\text{O}_2$  or  $\text{CO}$ , forms bubbles in the newly formed phases Figures 1b and 5.

**Figure 1)** (A) As received SiC/CAS composite. Note the exposed fibers on specimen surface. (B) Same as (A) after 1hr. exposure at 900°C with  $\text{Na}_2\text{SO}_4$  coating.

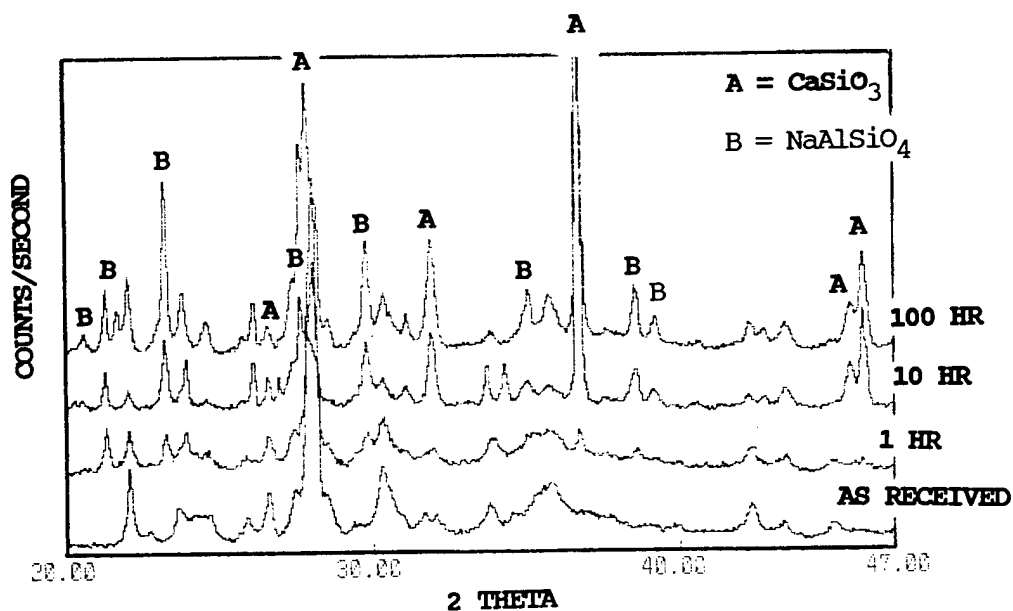
The X-ray diffraction patterns of samples tested for 1-, 10-, and 100- hours are similar and indicate that the same reaction products have formed. The specimen exposed for 1 hour had the same phases present as the longer exposures (10 and 100 hr.) but the relative intensities of the peaks were not the same. This indicates that phases formed during hot corrosion continue to form and crystallize with time producing a narrow high amplitude peak. The surface morphology can be seen in a scanning electron micrograph, Figure 5. The newly formed phases, from the exposure, are very brittle and numerous cracks have formed on the surface, Figures 5 and 6. Examination of the cross-sections of the 100-hour-exposed specimens revealed that the matrix material has been

**Figure 2)** X-ray diffraction pattern of SiC/CAS composite. Exposures were at 1-, 10- and 100-hours at 900°C with  $\text{Na}_2\text{SO}_4$  coating.

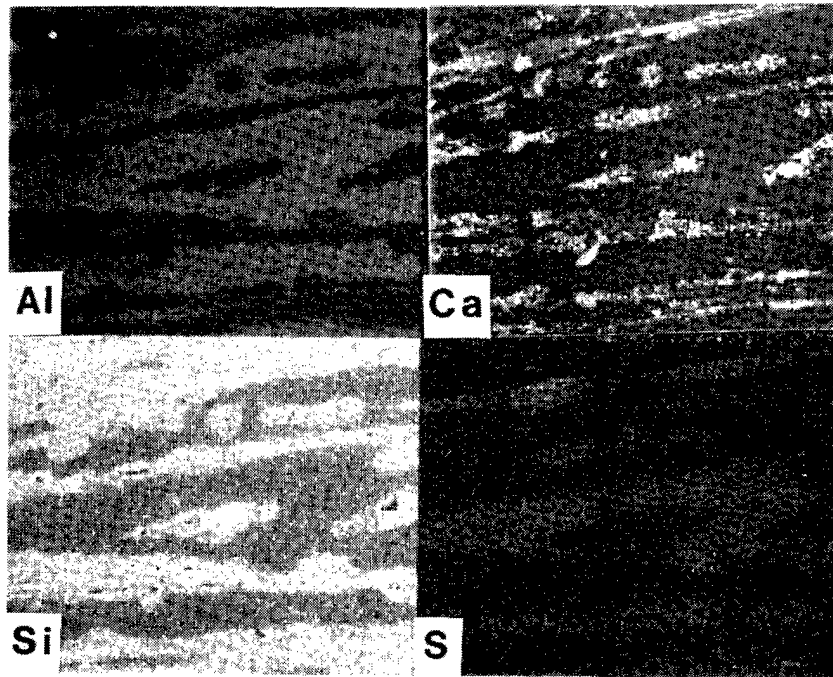
**Figure 3)** X-ray images taken of the surface of the SiC/CAS composite which was coated with  $\text{Na}_2\text{SO}_4$  and exposed at  $900^\circ\text{C}$  for 1 hr.

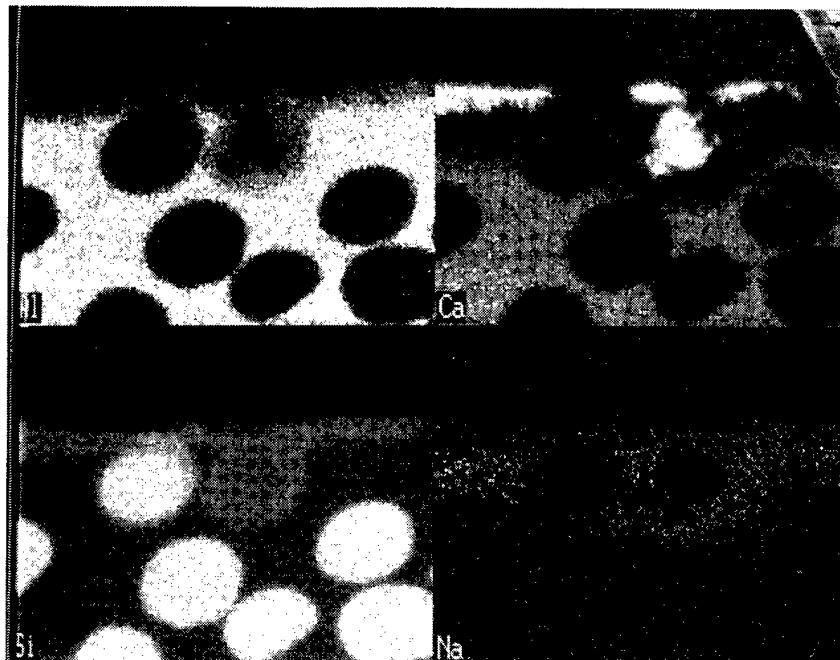
attacked by the molten salt. The elemental profile obtained from an energy dispersive spectrometer indicates that the fibers exposed on the surface of this specimen are severely attacked, Figure 4. The sulfur map did not indicate a gradient near the surface. This indicates that residual sodium sulfate was not present.

**Figure 4)** Elemental map taken of the cross-section of the SiC/CAS composite which was exposed to a salt coating at  $900^\circ\text{C}$  for 100 hrs.

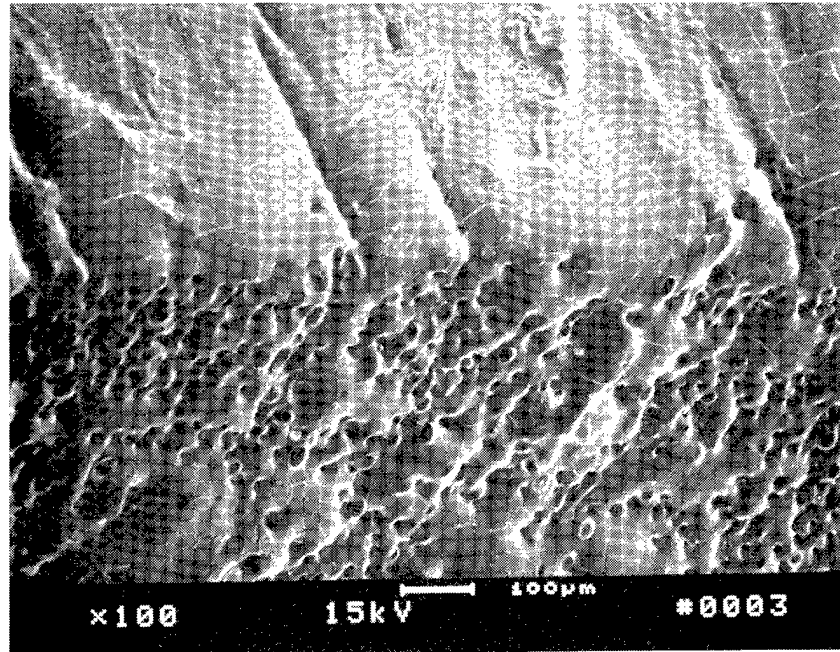
**Figure 5)** SEM image of SiC/CAS composite which was salt coated and exposed for 10 hr. at 900°C. Note the surface cracks and pores.

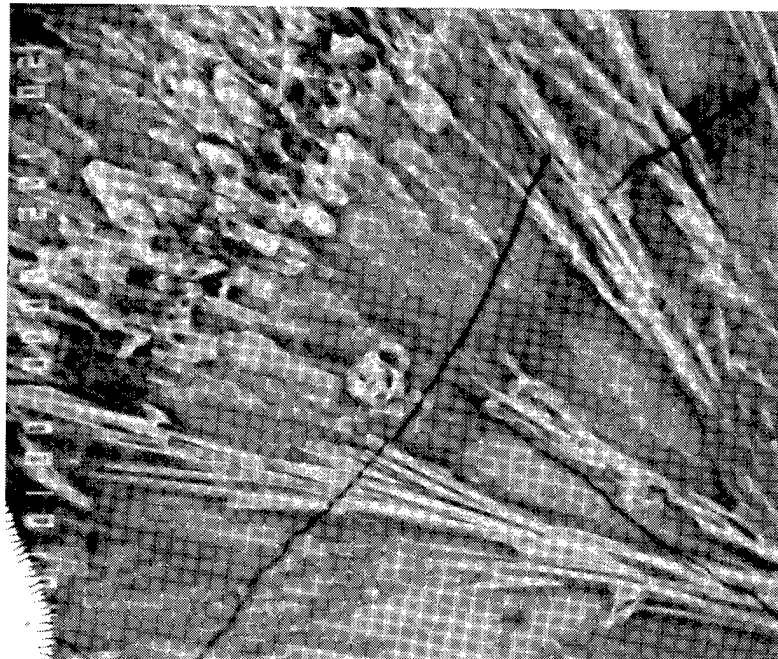
**Figure 6)** Backscattered SEM micrograph of SiC/CAS composite that was coated with  $\text{Na}_2\text{SO}_4$  and exposed at 900°C for 100 hrs.

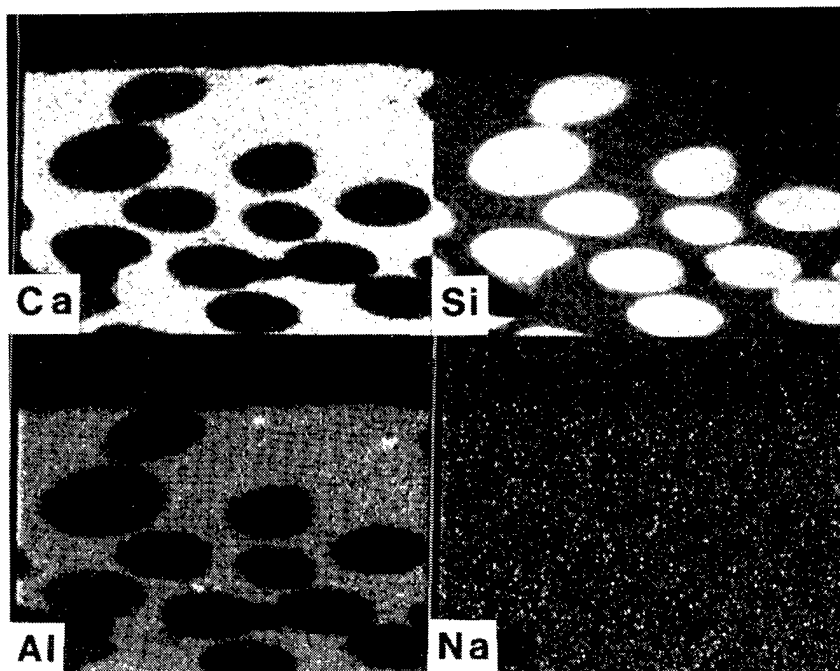
The X-ray diffraction data obtained from the noncoated specimen (exposed for 100 hours at 900°C) indicated that no new surface phases formed during the heat treatment. This can also be seen from the X-ray map of the cross-section of this specimen, Figure 7. The surface morphology of the uncoated specimens was similar to the as-received specimen except for the degradation of the reinforcing SiC fibers that were initially exposed to the surface.

Figure 7) Elemental map taken of the cross-section of the SiC/CAS composite which was exposed at 900°C for 100 hrs. Note that a reaction zone as seen in figure 4 is not present.

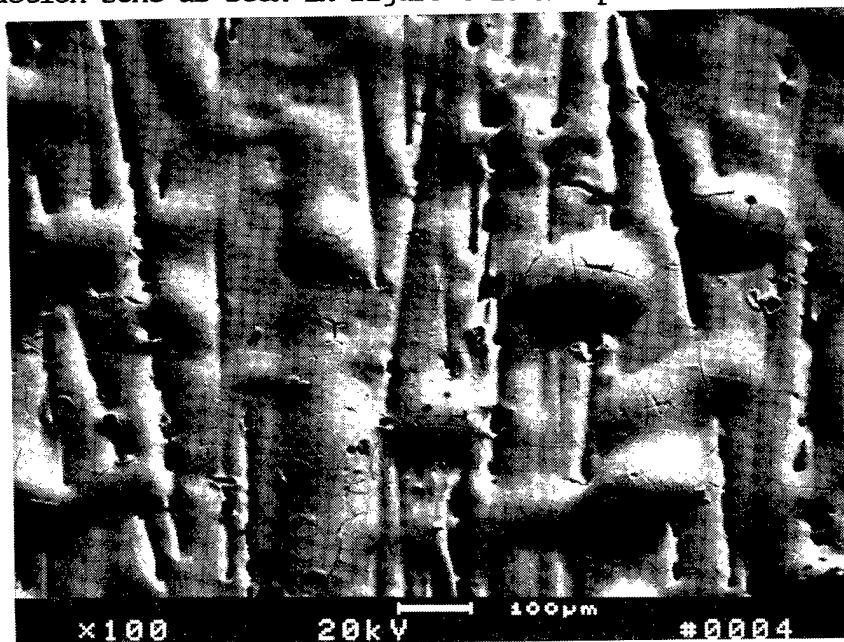
A molten crucible test was performed on the composite (SiC/CAS). This is a severe hot corrosion test that has been used in the past to evaluate turbine engine components. It should be noted that since the specimen is completely immersed in molten salt, the partial pressures of the constituents, most notably oxygen and  $\text{SO}_3$ , are different when compared to the salt coated hot corrosion specimens mentioned above. Therefore, it is expected that the thermodynamics and kinetics of the reactions change, and subsequently different reactions may occur. Sodium aluminosilicate ( $\text{NaAlSiO}_4$ ) was detected on the 10-hr. specimen, but calcium silicate did not form. The surface of the specimen was more severely attacked when compared to the coated specimens Figure 8. This

agrees with the work performed by D.W. McKee et al.<sup>9</sup> on hot corrosion of sintered SiC, in that at very low partial pressure of  $O_2$ , the SiC corroded very rapidly because the protective  $SiO_2$  layer fluxed into the melt. This shows the importance of the selection of the test method. In other words, it is imperative to simulate the engine environment as closely as possible. Bianco et al.<sup>10</sup> completed similar work with the hot corrosion of cordierite. They, however performed burner rig test and determined that a good correlation exists between burner rig tests and thin coating furnace test. Therefore, it is not recommended to use crucible tests for hot corrosion testing.

Figure 8) SEM micrograph of the SiC/CAS composite which was exposed to a molten crucible test for 1hr at 900°C. Note the severity of surface attack, and the formation of an amorphous phase.

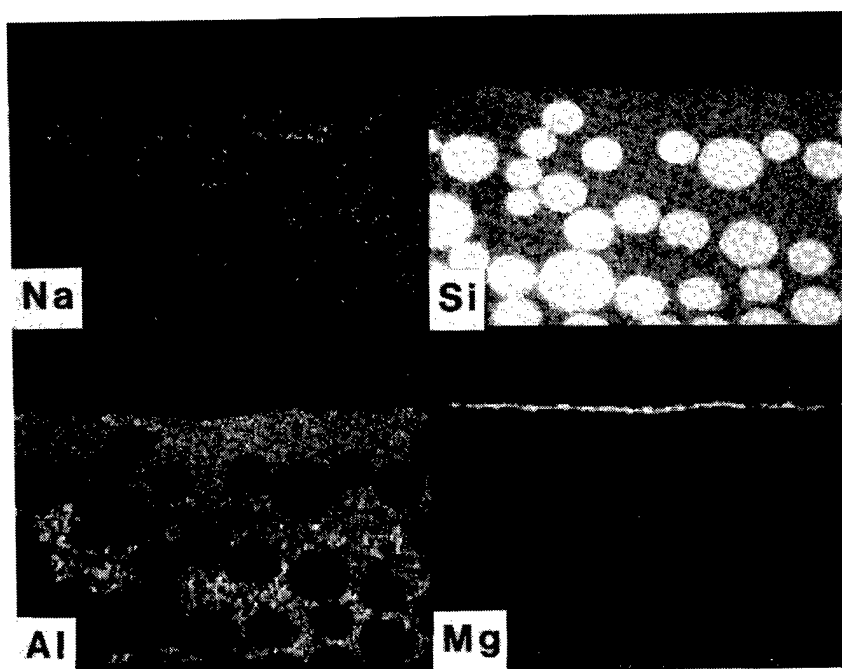
**Figure 10)** X-ray map of cross-section of SiC/LAS composite that was exposed at  $900^\circ\text{C}$  for 100 hours with a salt coating.

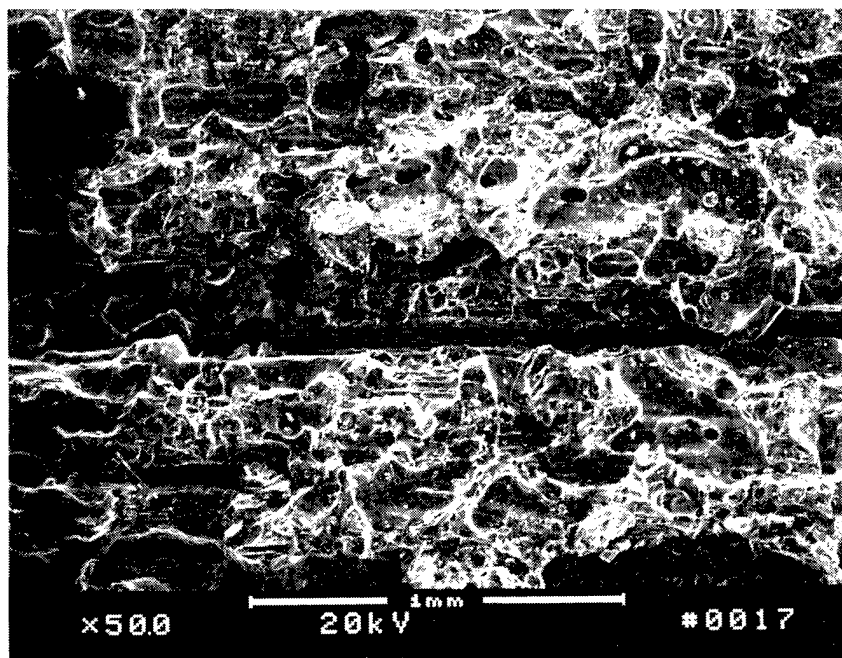
This SiC/LAS composite system behaved differently when it was exposed to a molten crucible test. The composite was severely attacked, in that the specimen dissolved in the salt ( $\text{Na}_2\text{SO}_4$ ) after 10 hours at  $900^\circ\text{C}$ . After a one hour exposure, in the crucible test, the specimen was intact, but the surface was severely attacked, figure 11. Therefore, it has been shown that thin film hot corrosion results differ from crucible test results of the same material. It has been suggested by N.S. Jacobson et al.<sup>11</sup>, that oxygen potential at the melt/specimen interface of a crucible test may be unrealistically low. This in turn alters the kinetics of the system and does not simulate what may be expected in a turbine environment.

Figure 11) Surface of SiC/LAS composite that was exposed in a molten crucible test for 1 hour.
